Matanuska-Susitna Borough LiDAR & Imagery Project Quality Assurance Report Matanuska Block V2

Written by Rick Guritz

Alaska Satellite Facility

March 28, 2013

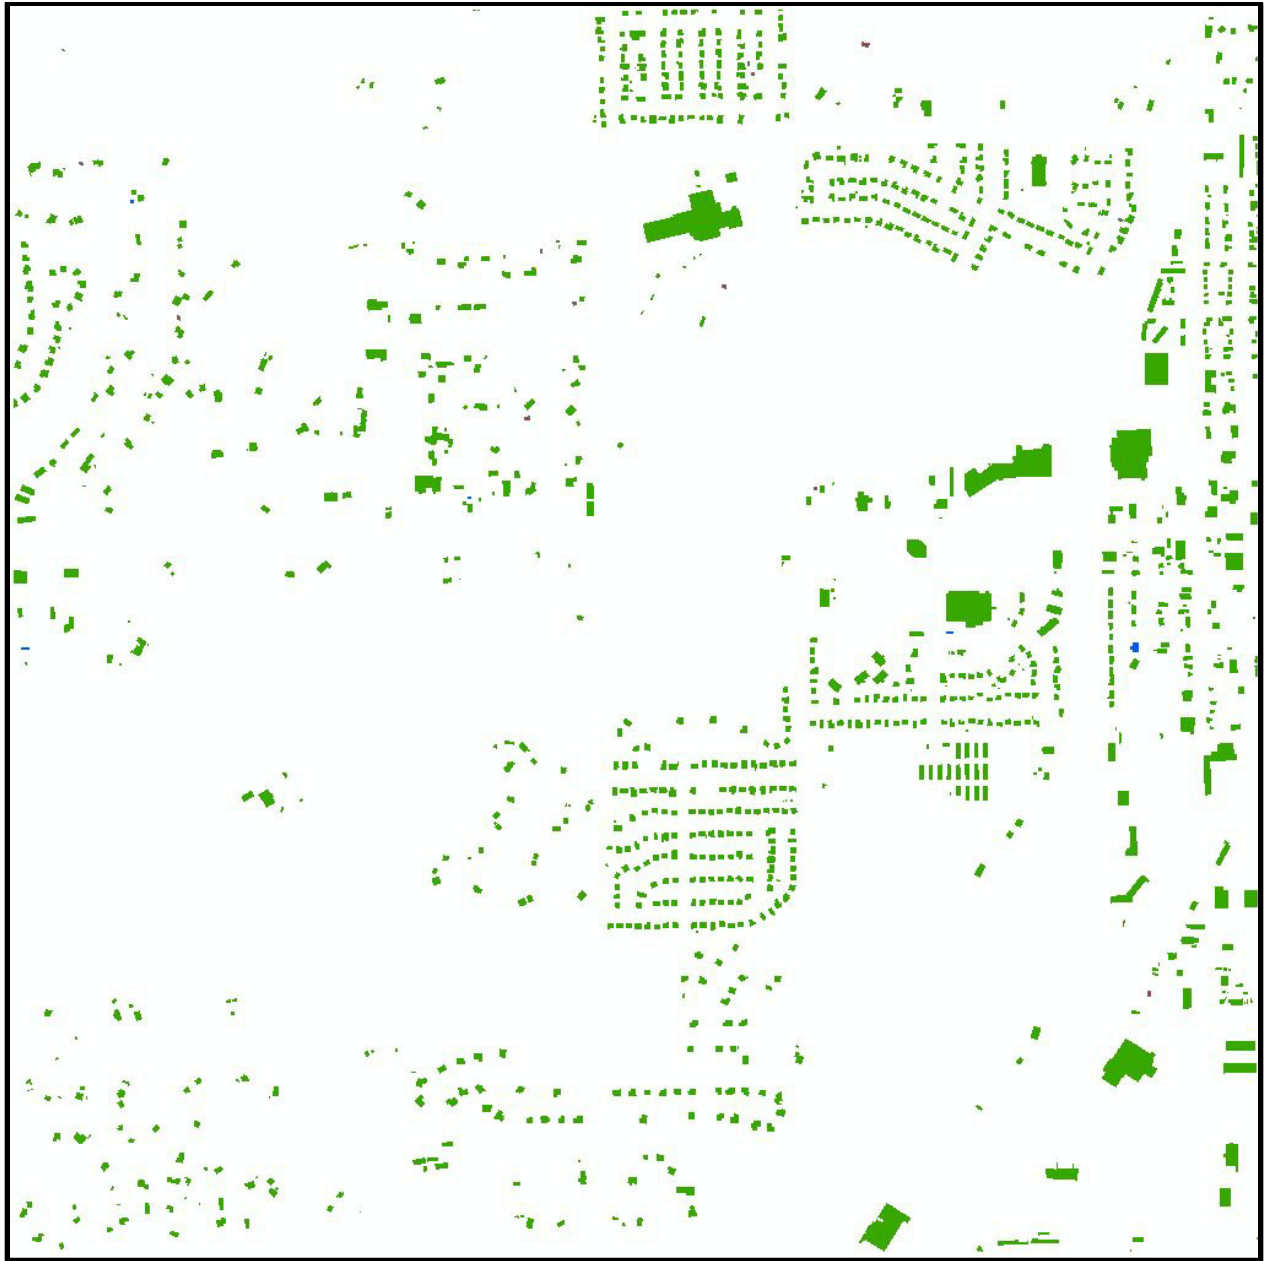
The building feature class is verified by performing a detailed examination of the quarter tile with the most buildings. Visual verification is performed on each building to the ortho imagery or canopy height difference classification (see Figure 43 and 44) looking for buildings that were missed or classified building that were incorrectly identified (false positives). Buildings of greater than 400 square feet should be included at 97% success rate. Separate feature classes are created for new buildings and buildings that were misclassified (false positives). Areas are calculated for new buildings and the accuracy for this quarter tile is checked and reported. Given the limited time, the quarter tile with the highest building density was checked for accuracy and reported as representative of the block. For the Matanuska block, tile MAT_024_SW was identified as the quarter tile with the most buildings in it, including 1197 buildings. I then performed my analysis and found 13 false positives of which 3 were greater than 400 square feet. There were 6 missed buildings of which 1 was greater than 400 square feet. If we only

consider buildings with 400 square feet or more, then there were 3 false positives and 1 missed building from 1043 correctly identified buildings. There were 4 errors from 1044 buildings giving a failure rate of 0.36% or an accuracy of 99.64% which exceeds the target accuracy of 97%. A final building analysis graphic (see Figure 45) was produced with accurate buildings (light blue), incorrect buildings (red), and new buildings (dark blue) to document results from the analysis. Separate feature classes for each of the three categories are also produced for further analysis and provided to the Matanuska-Susitna Borough GIS staff.

Figure 45, Building Analysis Results (Lt. Blue – Correct, Red – Incorrect, Dark Blue – Added)

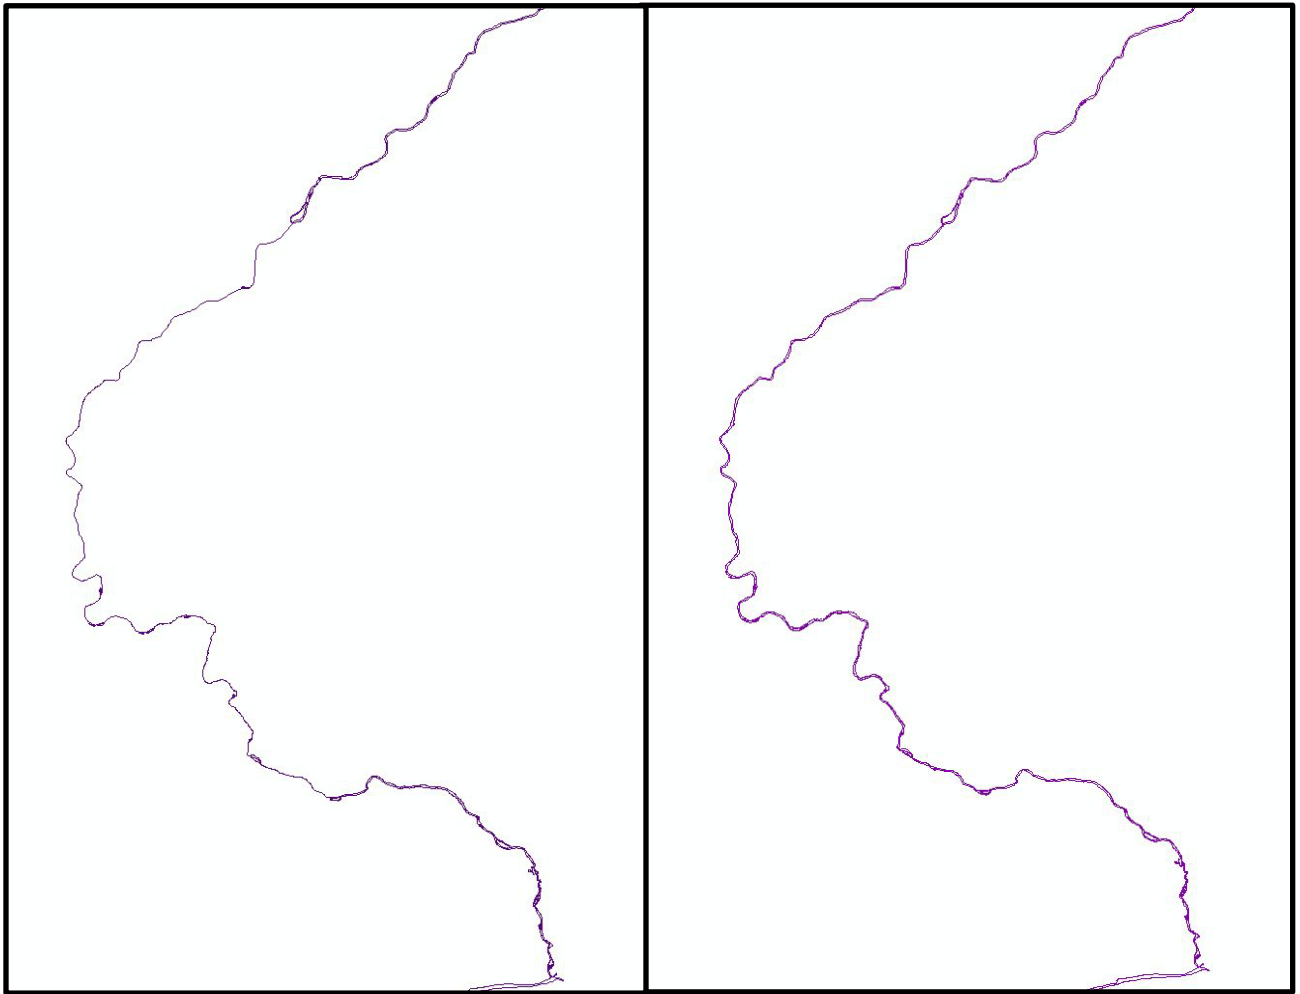
UAF reported missing shorelines of Moose Creek in double line drainages – On 7/10/2012, UAF reported issues with the double break line drainages. In particular, Moose Creek was missing one of its shorelines (see Figure 51).

Figure 51, Moose Creek Double Breakline Drainage missing lines.

Delivery 3 – On 7/10/2012, Aerometric staged hydro break lines on their FTP site.

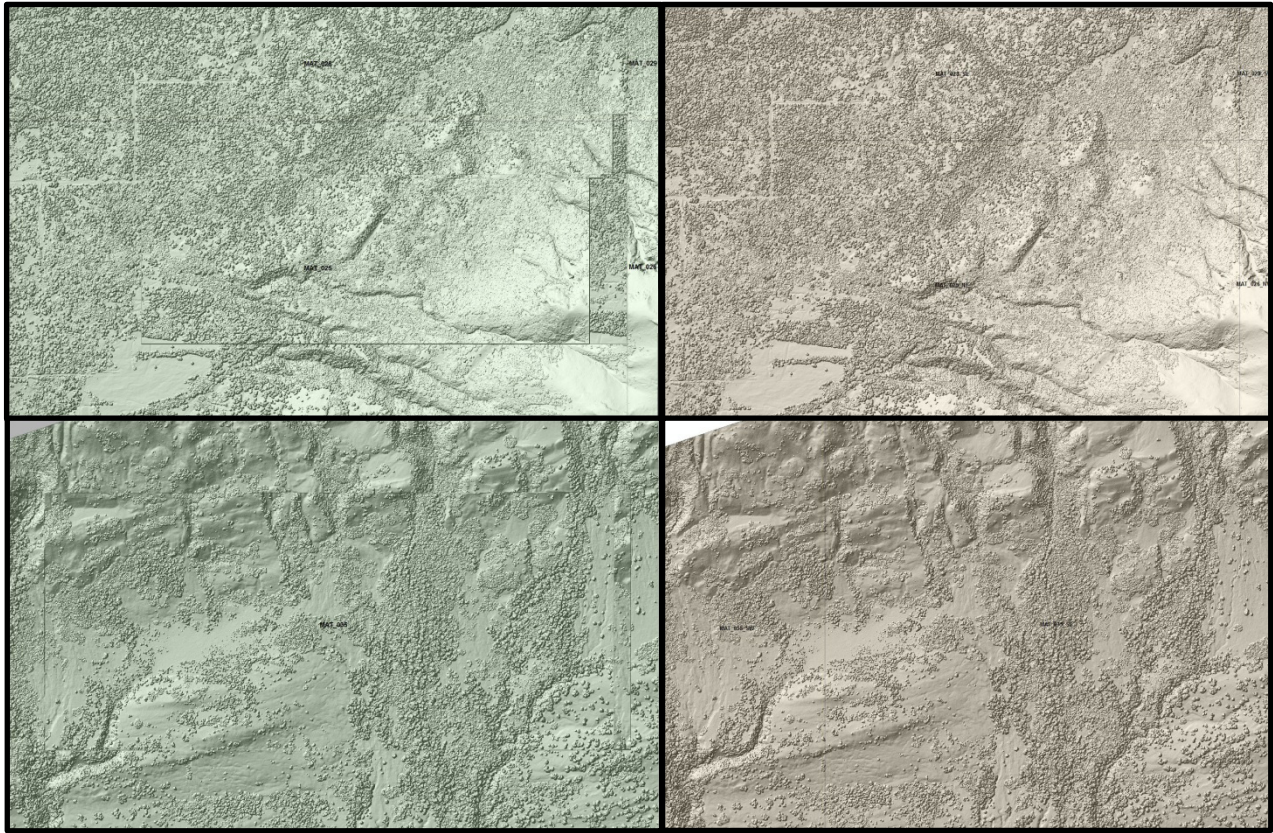
UAF reported seams and artifacts in first return DSM – On 7/10/2012, UAF reported problems with the first return DSM. There were visible seams and discontinuities that looked like shifts in the data. Seven regions were identified as problem areas documented in screen captures (see Figures 52-55). Tiles affected include: MAT_025, MAT_035, MAT_065, MAT_070, MAT_071, MAT_075, and MAT_076.

Figure 52, Seams and artifacts in shaded relief of first return DSM (MAT_025 and MAT_035).

Delivery 5 – On 7/23/2012, Aerometric delivered to UAF a disk containing corrected DSM's for Matanuska block.

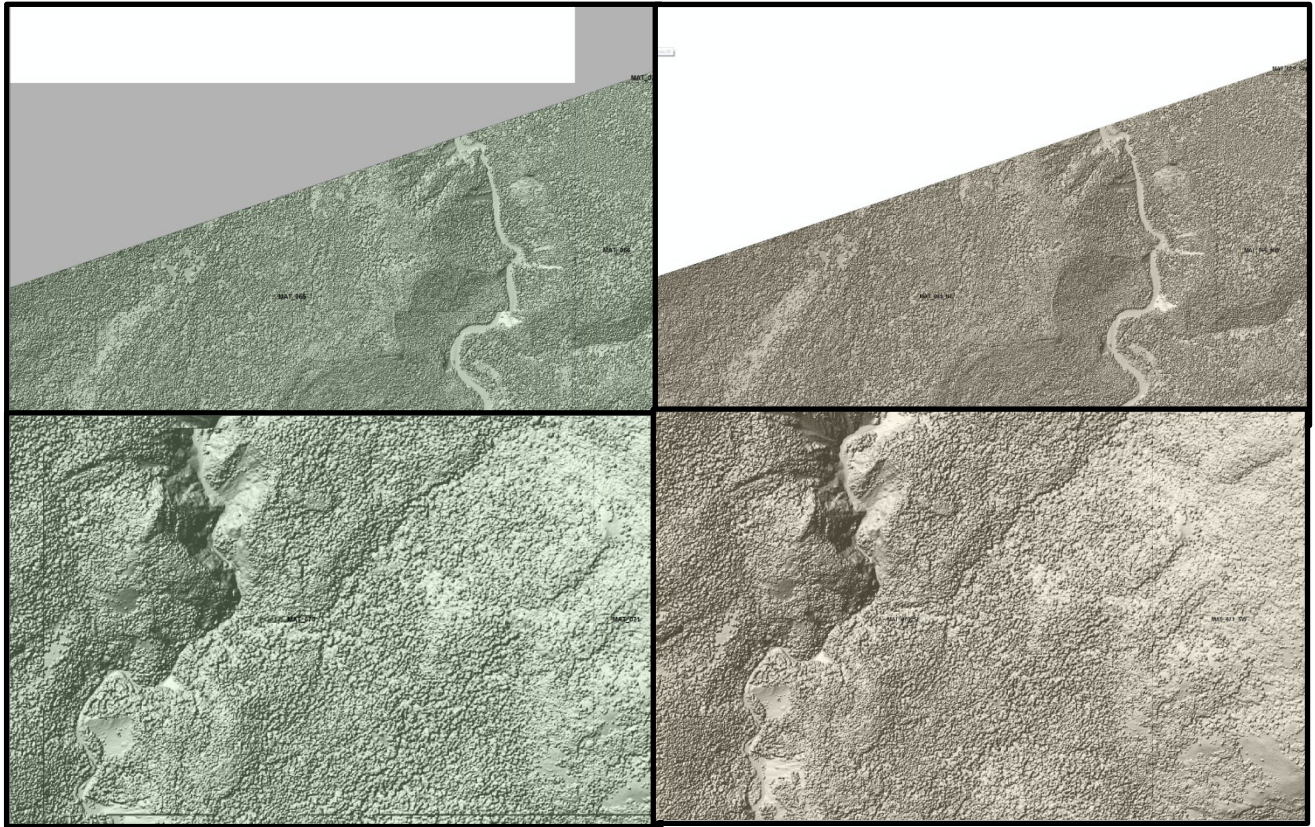
Figure 53, Seams and artifacts in shaded relief of first return DSM (MAT_065 and MAT_070).

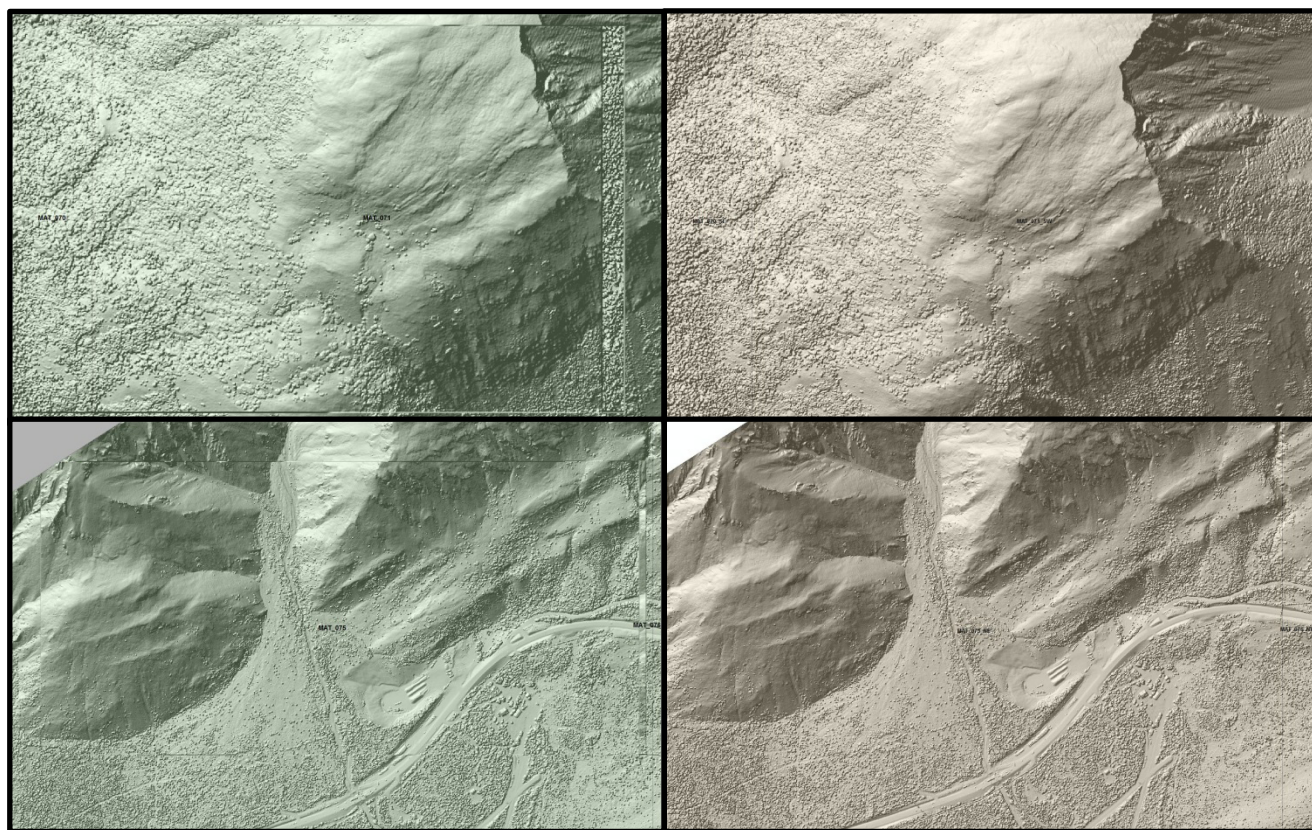
Figure 54, Seams and artifacts in shaded relief of first return DSM (MAT_071 and MAT_075).

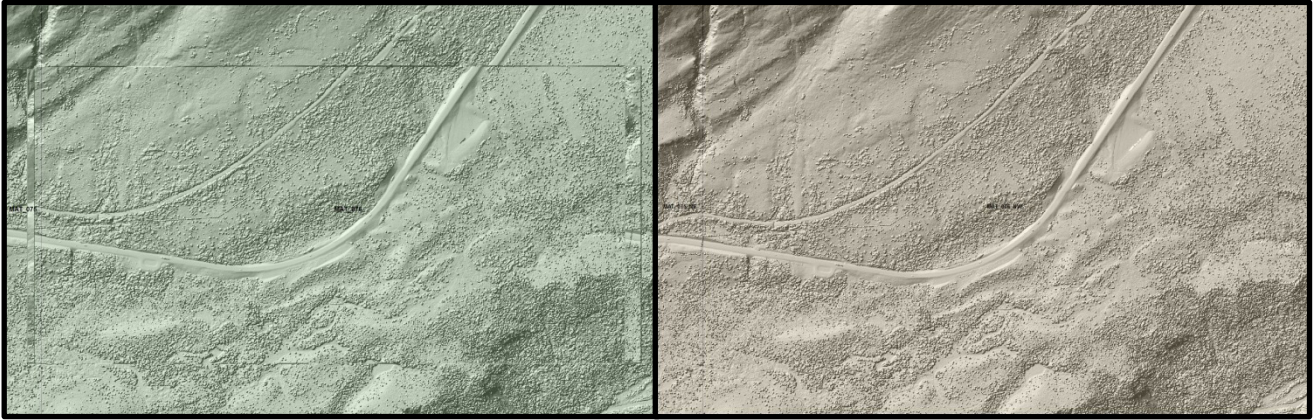
Figure 55, Seams and artifacts in shaded relief of first return DSM (MAT_076).

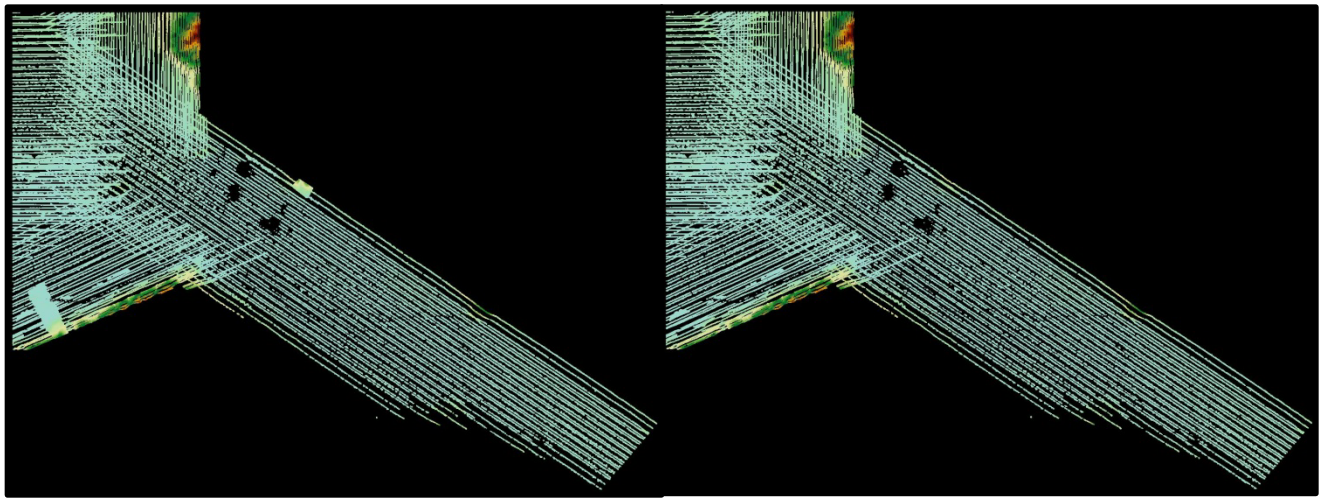
UAF reported results of LAS point cloud assessment – On 7/27/2012, UAF reported (1) cross calibration swaths that need to be removed from unclassified class 1 (see Figure 56), (2) low veg class 3 still contains points over water, (3) medium and high veg class should also be checked, (4) power transmission lines class 11 has discontinuous power lines (see Figure 57). UAF requested that these data quality issues be investigated.

Figure 56, Cross calibration swaths removed from unclassified class 1 LAS point cloud data.

Delivery 7 – On 7/29/2012, Aerometric staged 7 corrected LAS point cloud tiles, in which cross calibration swaths were removed or water classifications were improved, on their FTP site.

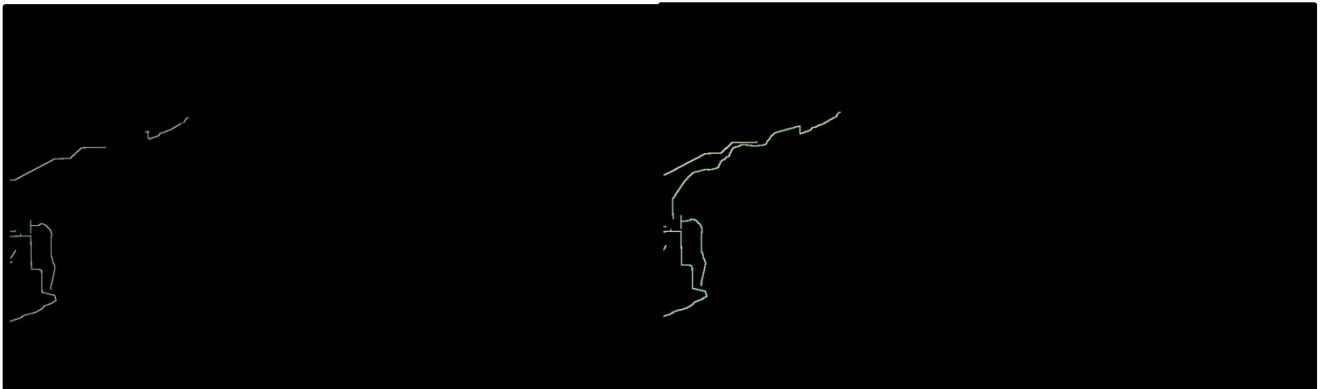
Figure 57, Power transmission lines class 11 discontinuous in Matanuska block.

Delivery 10 – On 8/13/2012, Aerometric delivered to UAF a disk containing LAS point cloud data with reclassified power lines for Matanuska and partial Core Area blocks. **This final delivery of data completed the final corrections that were needed for acceptance of the Matanuska block.**

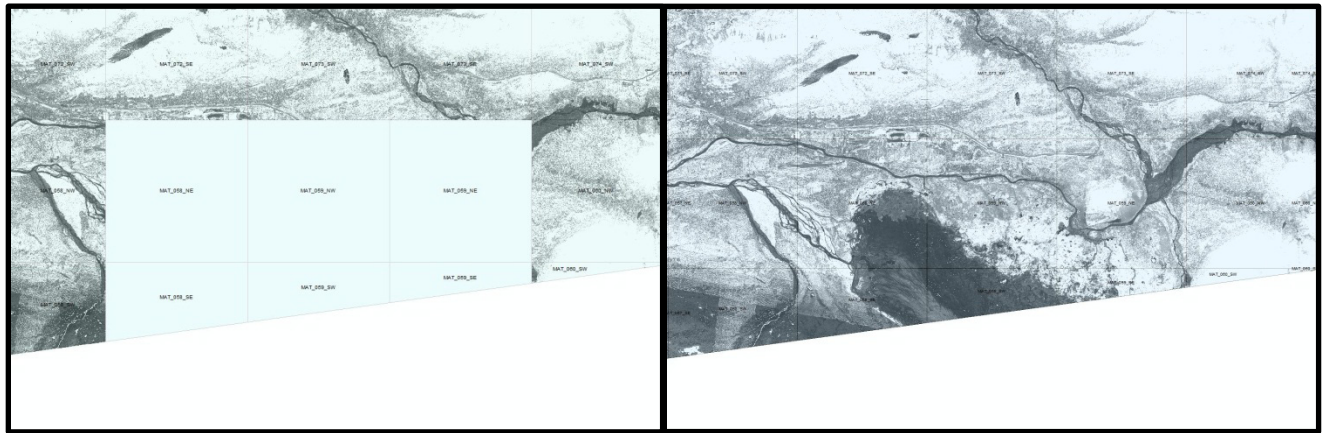
UAF reported six missing LiDAR intensity tiles – On 8/6/2012, UAF reported a section of missing LiDAR intensity data mosaic (see Figure 58). This was identified as six missing quarter tiles that were not included in the delivery.

Figure 58, Six missing quarter tiles in LiDAR Intensity data.

Delivery 9 – On 8/8/2012, Aerometric staged 6 corrected LiDAR intensity tiles for Matanuska block on their FTP site.

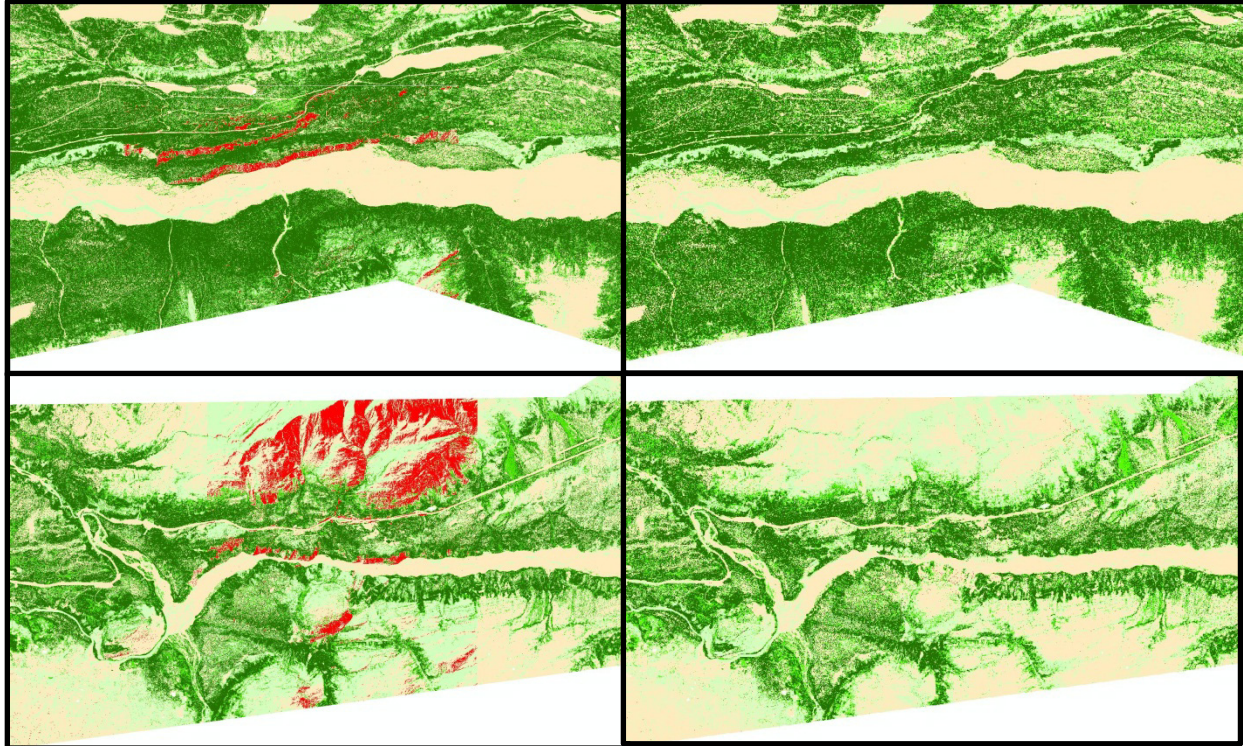
UAF reported negative heights in canopy height estimate – On 3/21/2013, UAF reported negative values in the canopy height estimate product. This test showed that some areas had a bare-Earth DEM that was higher than the first-return DSM (see Figure 59).

Figure 59, Negative heights detected in canopy height estimate when subtracting bare-Earth DEM from First-Return DSM (tiles: MAT_053 and MAT_074).

Delivery 12 – Aerometric delivered to UAF a delivery disk on 03/25/2013 containing a redelivery for Talkeetna and Matanuska blocks which addressed the negative canopy height estimates. This was later identified as a resampling issue due to work flow inconsistencies.
