Matanuska-Susitna Borough LiDAR & Imagery Project Quality Assurance Report Point Mackenzie Block (V2)

Written by Rick Guritz

Alaska Satellite Facility

February 11, 2013

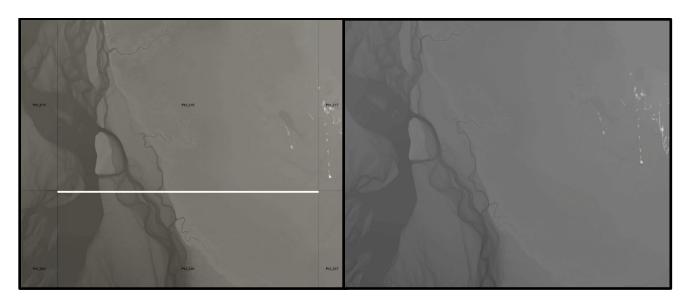
Detected Seam in bare-Earth DEM – On 11/09/2011, an observed seam was reported when trying to mosaic bare-Earth DEM tiles. This seam was several pixels wide running west to East between two sets of tiles (see Figure 45).

Figure 45, Seam in Bare-Earth DEM (Left) Corrected (Right).

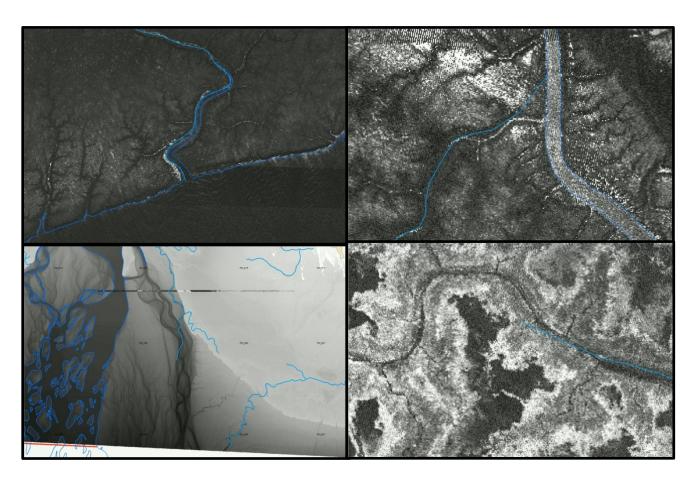
Anomalies identified in single breaklines – On 11/10/2011, ten screen captures were provided to Aerometric identifying inconsistencies between single breaklines and either LiDAR intensity data or the bare-Earth DEM (see Figure 46-47). These were primarily over channels in the mud flats. After review, Aerometric decided to remove most of these breaklines because they were too difficult to determine accurately. The corrected hydro layers have very few breaklines in the mud flats (see Figure 48).

Figure 46, Single Hydro Breakline Inaccuracies.

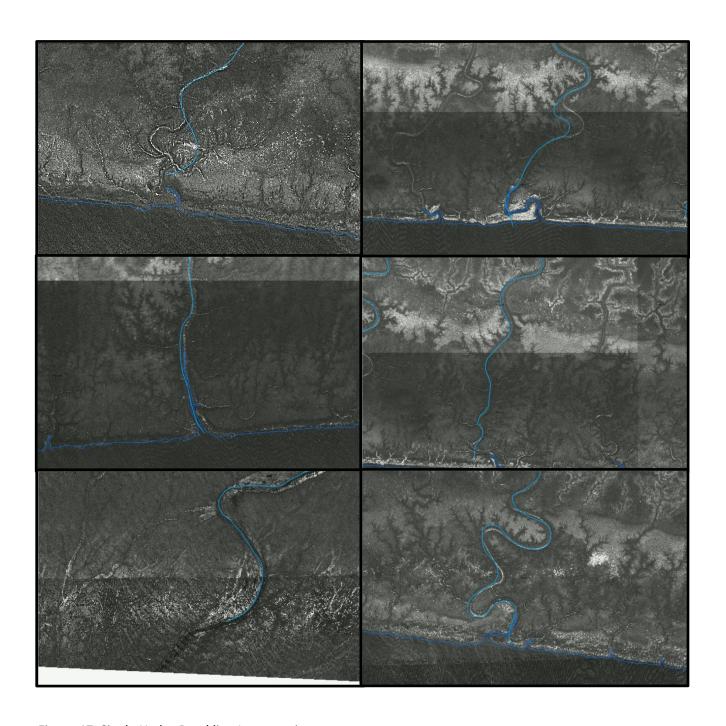
Figure 47, Single Hydro Breakline Inaccuracies.

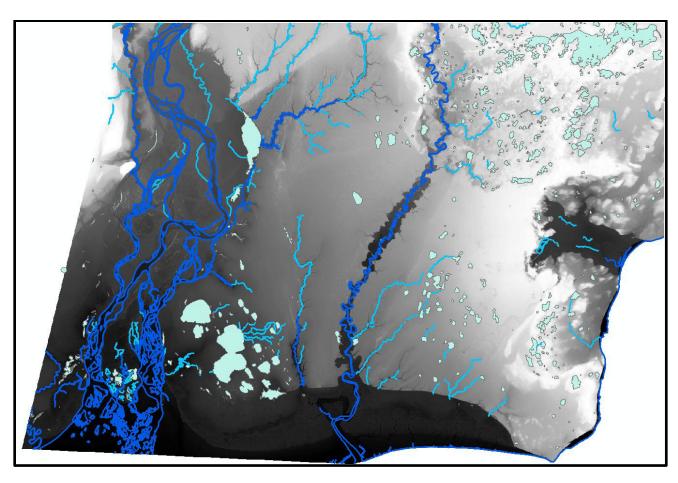
Figure 48, Corrected Hydro GIS Layers.

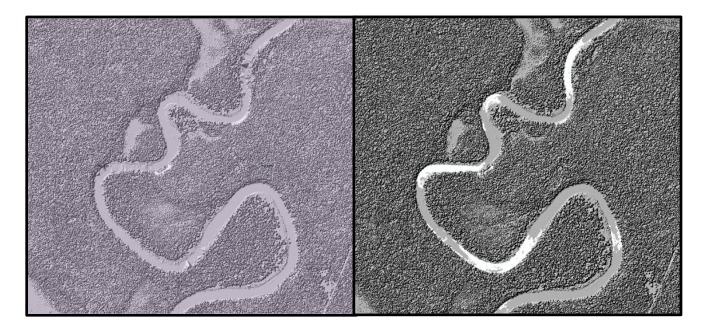
Anomalies in First Return DSM – On 11/11/2011, interpolation errors were observed in portions of the Little Susitna River (See Figure 49). In a true first return product, the LiDAR data should be evaluated on a cell by cell basis using the delivery grid as the basis for evaluation. All valid LiDAR returns (excluding points marked as withheld, class 1 and 7) should be evaluated for the highest return for that cell. For cells over water, there may not be a valid return for that cell, in which case the cell should be set to NoData. In discussion with Aerometric, they were using interpolation to fill holes over water which is undesirable. They were also using a gridding process that did not provide a true first return gridded product. After discussion, Aerometric was asked to change their processing methods to something that would provide a true first return product. This change was considered essential for a true canopy height product to be generated and for cross validation between gridded data and LiDAR point cloud data.

Figure 49, Interpolation Artifacts in First-Return DSM (Left), Corrected (Right).

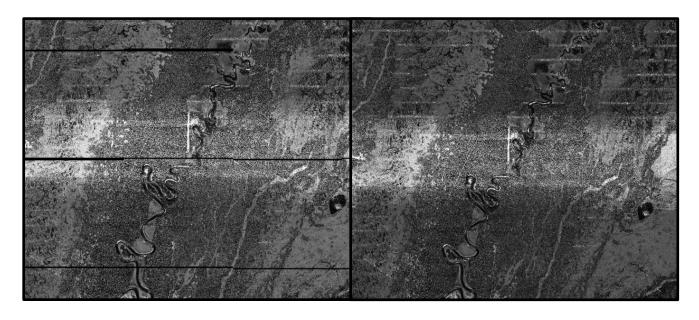
Detected Seams in LiDAR Intensity data – On 11/11/2011, observed seams were reported when trying to mosaic LiDAR Internsity data (see Figure 50). The seams were very obvious running from West to East and up to several pixels wide in places. After further investigation by Aerometric, they decided to use raster catalogs within the block geodatabase for all raster grids for future deliveries. This change eliminated the presence of seams in the data. It also was a much improved method for delivering raster data than what was initially used.

Figure 50, Seams in LiDAR intensity mosaic (Left), corrected (Right).

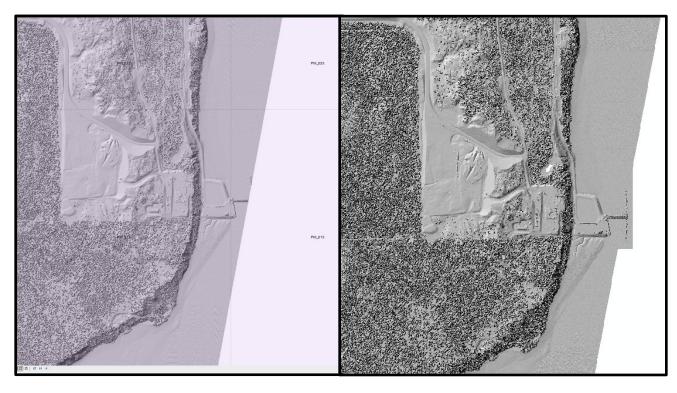
Clipping of Point Mackenzie Dock – On 11/11/2011, during visual assessment of the shaded relief product clipping of the Point Mackenzie dock was identified and reported (see Figure 51). An exception to the original block boundary was made to include the dock structure in both LiDAR intensity and first return DSM. This is an important structure that should be included in the resulting data. It should be noted that the original coverage requested by Matanuska-Susitna Borough GIS staff was the source of the error. Fortunately, the LiDAR coverage could be adjusted to cover the entire dock and breakwater.

Figure 51, Coverage Gap (Port) in First Return (Left), Extended (Right).

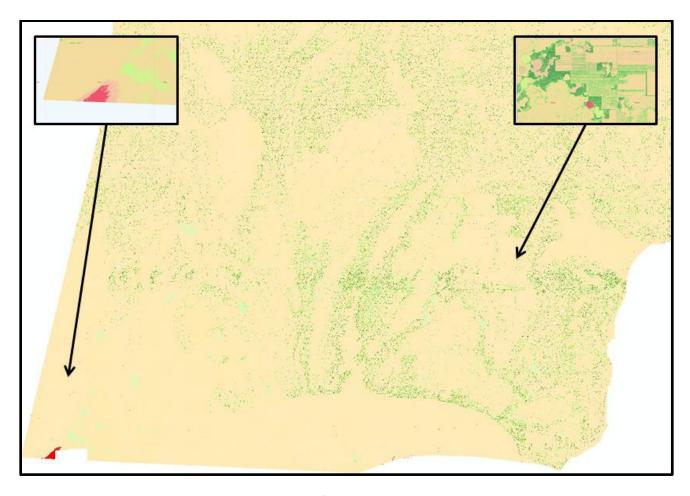
Negative values in canopy height difference – On 11/22/2011, negative values greater than -1 foot was observed in two locations of the Point Mackenzie block (see Figure 52). One was in the Susitna River delta, which was attributed to tidal fluctuations. The other was an area near some agricultural fields. One of these errors was eliminated when the rigorous first return DSM product was generated (See Figure 53). For our evaluation, we expect noise levels to be on the order of plus or minus one foot. Any negative values greater than one foot are not real and should be eliminated in the data.

Figure 52, Canopy Height – FR minus BE, Regions of negative values over -1.

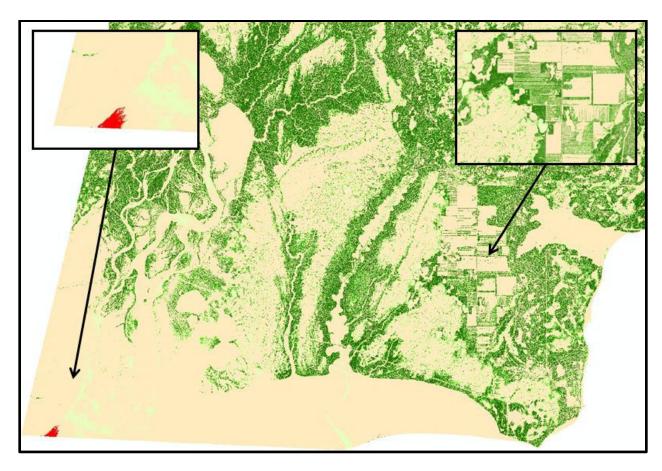
Figure 53, Corrected Canopy Height, Regions of negative values over -1.

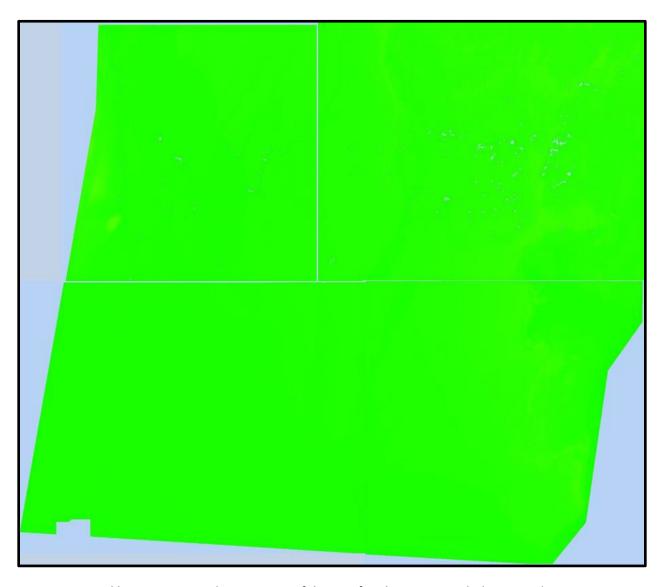
Low Vegetation not useful as initially defined 0-6 feet – On 11/23/2011, Aerometric was informed that the low vegetation class as initially defined with structures from 0-6 feet. There was no difference from the spatial extent of low vegetation and ground classes (See Figure 54). Given an accepted noise level in the data of one foot, UAF suggested that they redefine low vegetation as 1 to 6 feet. This should define a tighter spatial extent than ground and actually be useful, instead of redundant.

Figure 54, Initial low vegetation class not as useful at 0-6 feet because it includes ground noise.

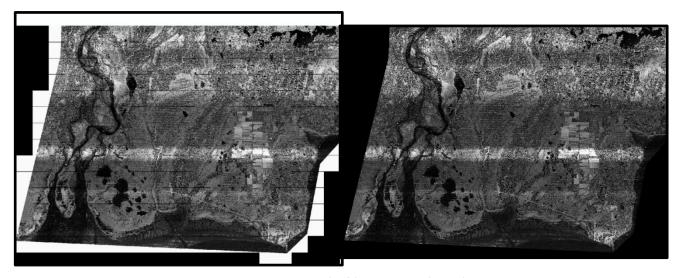
LiDAR intensity boarder not set to NoData - On 12/16/2011, UAF reported that fill values outside the block boundary were set to 249 or white and 0 or black (See Figure 55). UAF requested that these should be set to NoData to be similar to the bare-Earth and First-Return gridded products.

Figure 55, Fill values around good data inconsistent (Left), corrected (Right).

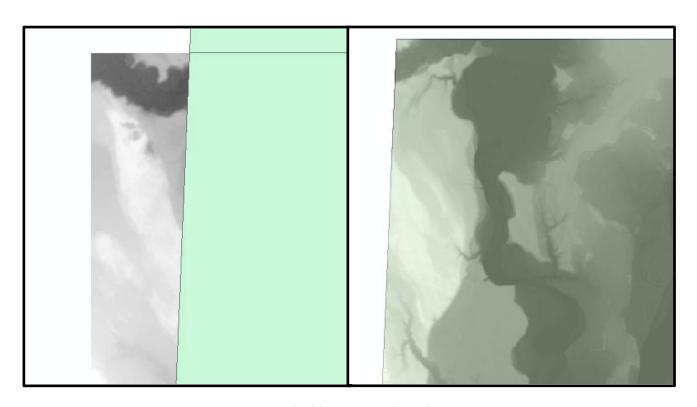
Bare-Earth DEM needs to be trimmed to block boundary – On 12/20/2011, UAF reported bare-Earth tile PM_063 needs to be trimmed to the block boundary (see Figure 56). With data extending beyond

the block boundary, it made for large differences to be detected when subtracting the bare-Earth DEM from the first-return DSM. UAF encouraged Aerometric to produce and deliver a block boundary layer with its tile grids in future deliveries.

Figure 56, Bare-Earth DEM needs trimming (Left), corrected (Right).

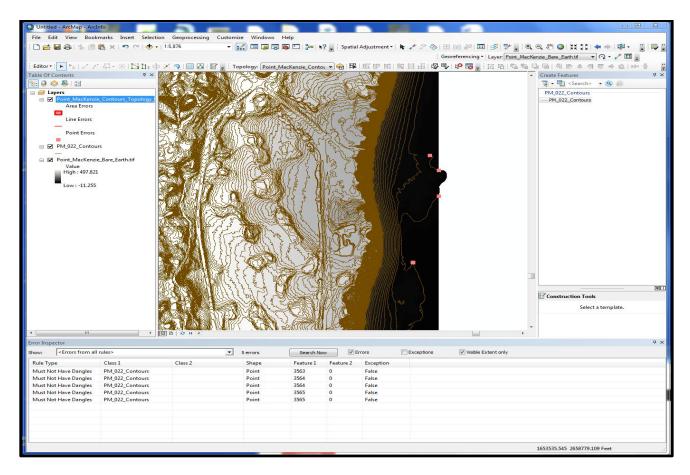
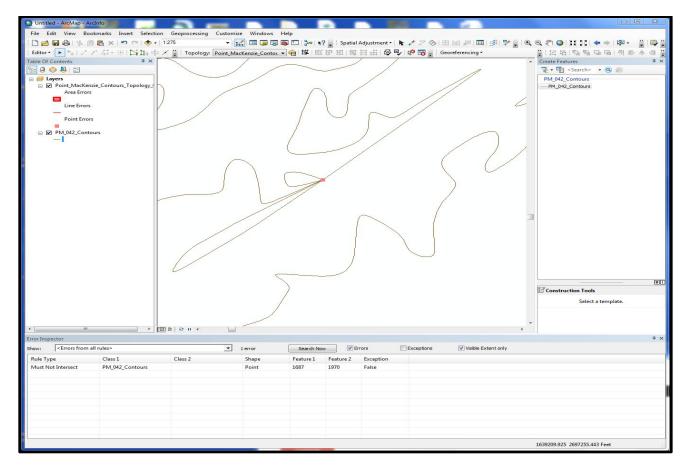
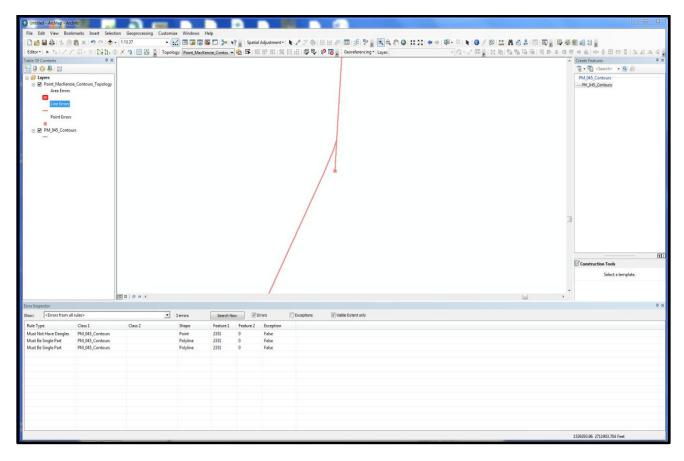
Contour topology errors – On 12/28/2011, UAF reported three tiles (PM022, PM042, and PM045) with contour topology errors (See Figure 57-59). This was determined after testing four tiles that contained the largest slopes and topology rules that were supplied by the Matanuska-Susitna Borough staff including: must not overlap, must not intersect, must not have dangles (except at tile edges), and must be single part.

Figure 57, Topology Errors in Contours (PM022).

Figure 58, Topology Errors in Contours (PM042).

Figure 59, Topology Errors in Contours (PM045).

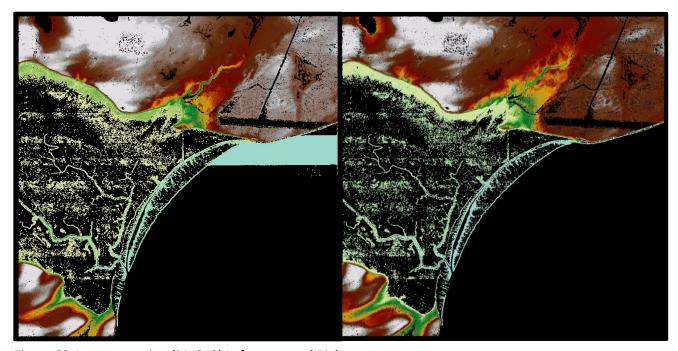
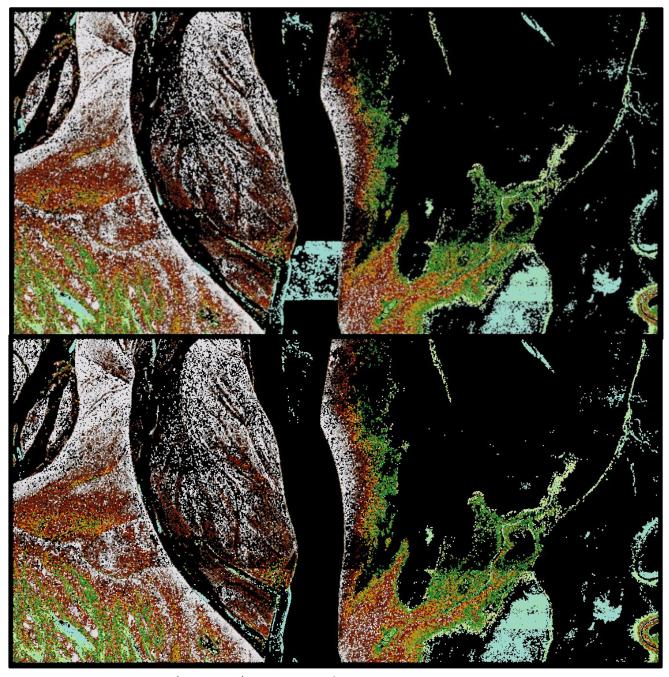
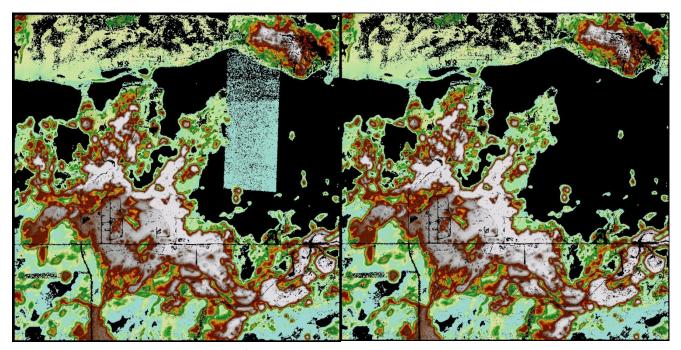
Low Vegetation errors – On 03/28/2012, UAF reported additional low vegetation errors that should be fixed (See Figure 60- 62). These include: the northern extent of cook inlet still has low vegetation over water (PM043), a block section of the Susitna River water classified as low vegetation (PM046NE and PM047NW), and a section of Big Lake that is classified as low vegetation (PM070).

Figure 60, Low vegetation (PM043) Left, corrected Right.

Figure 61, Low Vegetation (PM046-47) Top, corrected Bottom.

Figure 62, Low Vegetation (PM070) Left, corrected Right.

Delivery 6 – Aerometric delivered to UAF by FTP on 03/29/2012 fixes to the requested tiles of new LAS point cloud data to fix the low vegetation errors that were reported. **This final delivery of data completed the final corrections that were needed for acceptance of the Point Mackenzie block.**

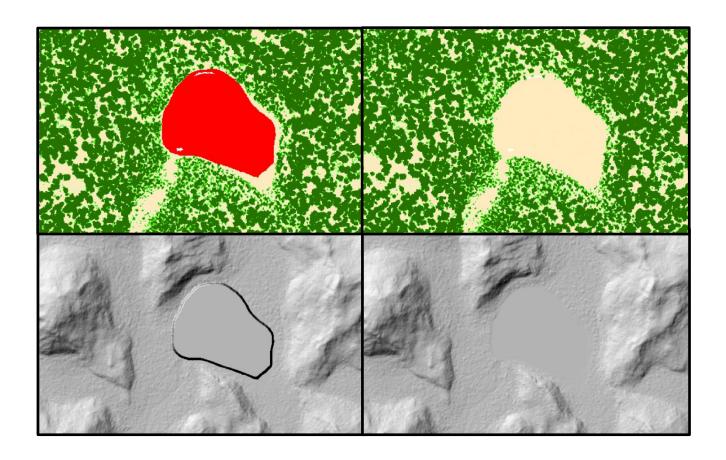
Lake Height Error – On 2/11/2013, UAF reported a bad lake height that differed between first return DSM and bare earth DEM by -97 feet (PM_068_DEM). This was observed in the canopy height classification as red and also showed up in the shaded bare earth DEM (See Figure 63).

Figure 63, Lake Height Error (PM068) Left, corrected Right.

Delivery 8 – Aerometric staged to their ftp, a corrected bare earth DEM and shaded relief tile for PM_068_DEM.
