Matanuska-Susitna Borough LiDAR & Imagery Project Quality Assurance Report Matanuska Block V2

Written by Rick Guritz

Alaska Satellite Facility

March 28, 2013

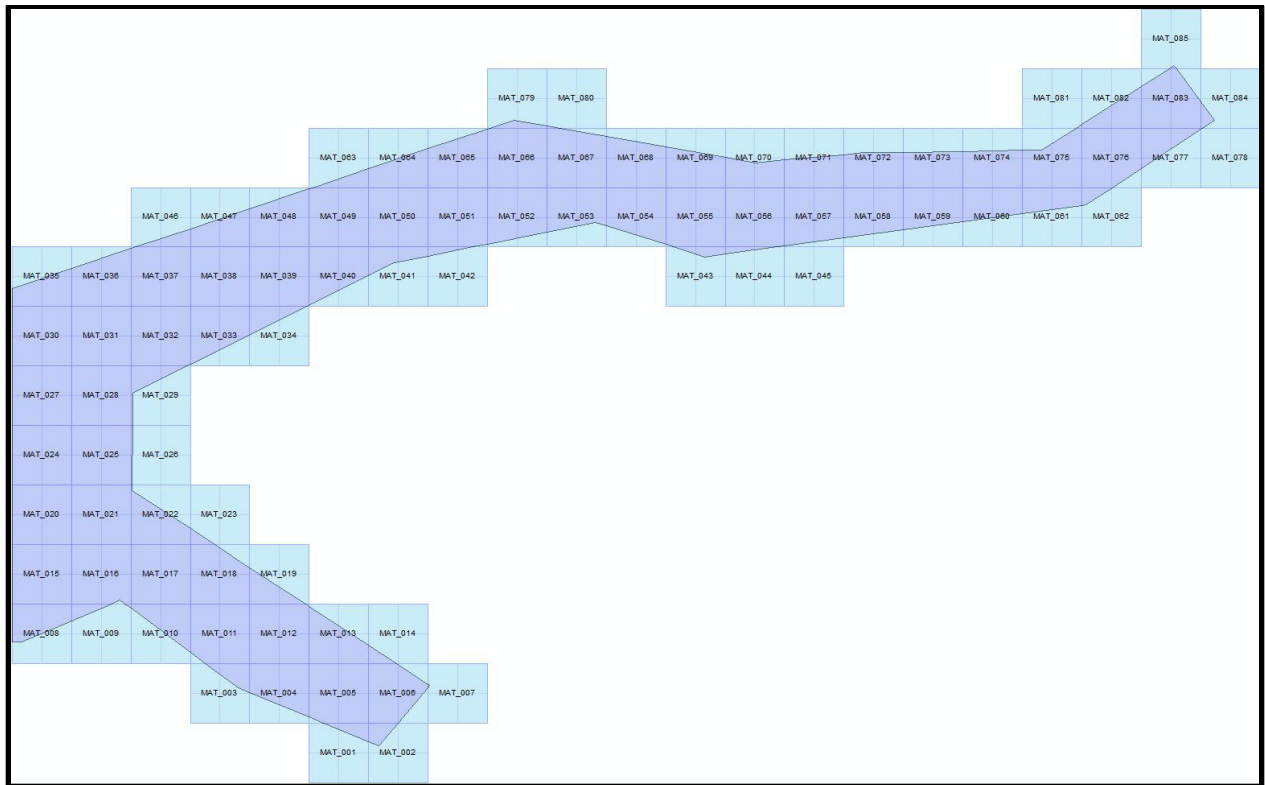
Figure 2, Contractor Supplied GIS Layers. Full tile (green), quarter tile (light green), and block boundary (green).

The contractor supplied GIS layers including block boundary, full and quarter tile indexes were displayed and evaluated to insure consistency with the original project coverage feature class (see Figure 2). The raster catalogs stored in the block geodatabase were combined into large scale raster mosaics and stored as geotiff products for evaluation purposes. Shaded relief images were produced from each of the surface elevation products to evaluate completeness of coverage, gaps, seams, or other data anomalies. The intensity image mosaic was also evaluated for completeness of coverage and quality of data. We observed variability in the LiDAR intensity data that is typical for this type of data. This is due

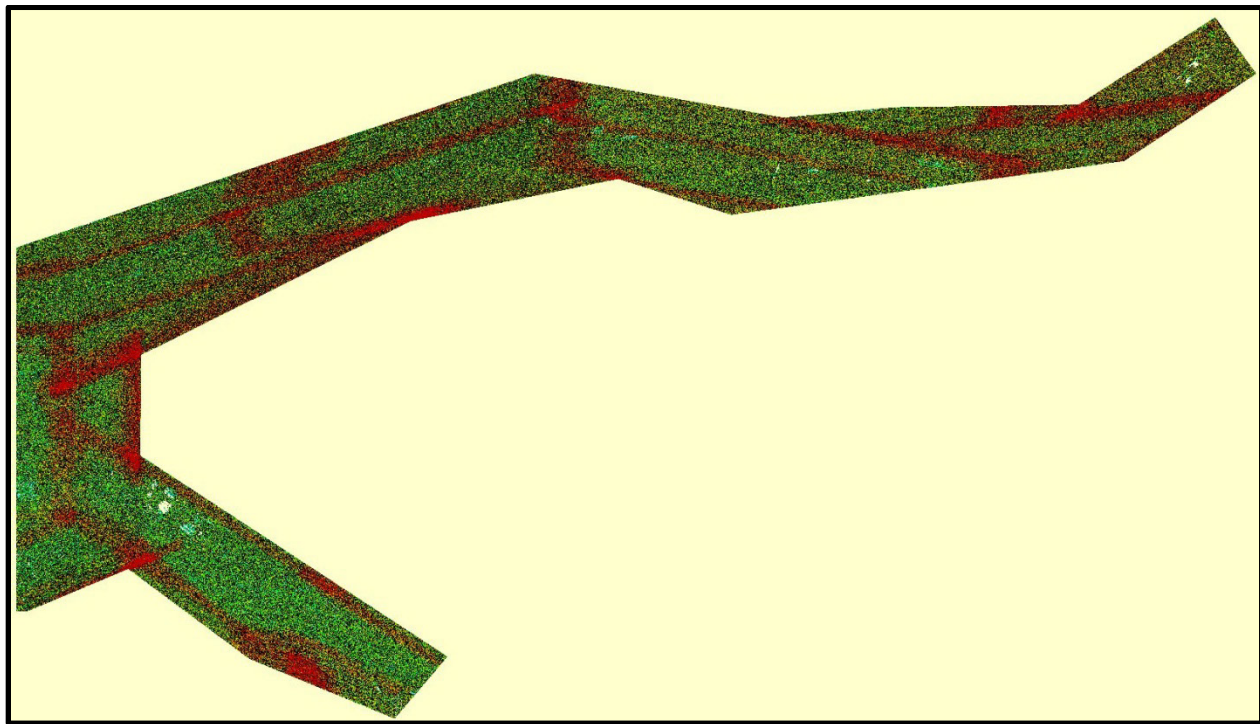
Figure 4, LiDAR Point Count

Point Density was determined using LAS tools provided by Aerometric. The application provides an ability to count point density creating ESRI ASCII GRID files for each tile. Global Mapper was used to read and display all of these grid files for the block (see Figure 4). We had to limit the point density per cell to a maximum of 12 points clamping values greater to that value so that the color map would show sufficient color variation at the low end. Point density is displayed using a color map from blue (low) to red (high). The grid spacing used for the evaluation was 4 feet per pixel, 2*NPS of 0.6 meter as specified

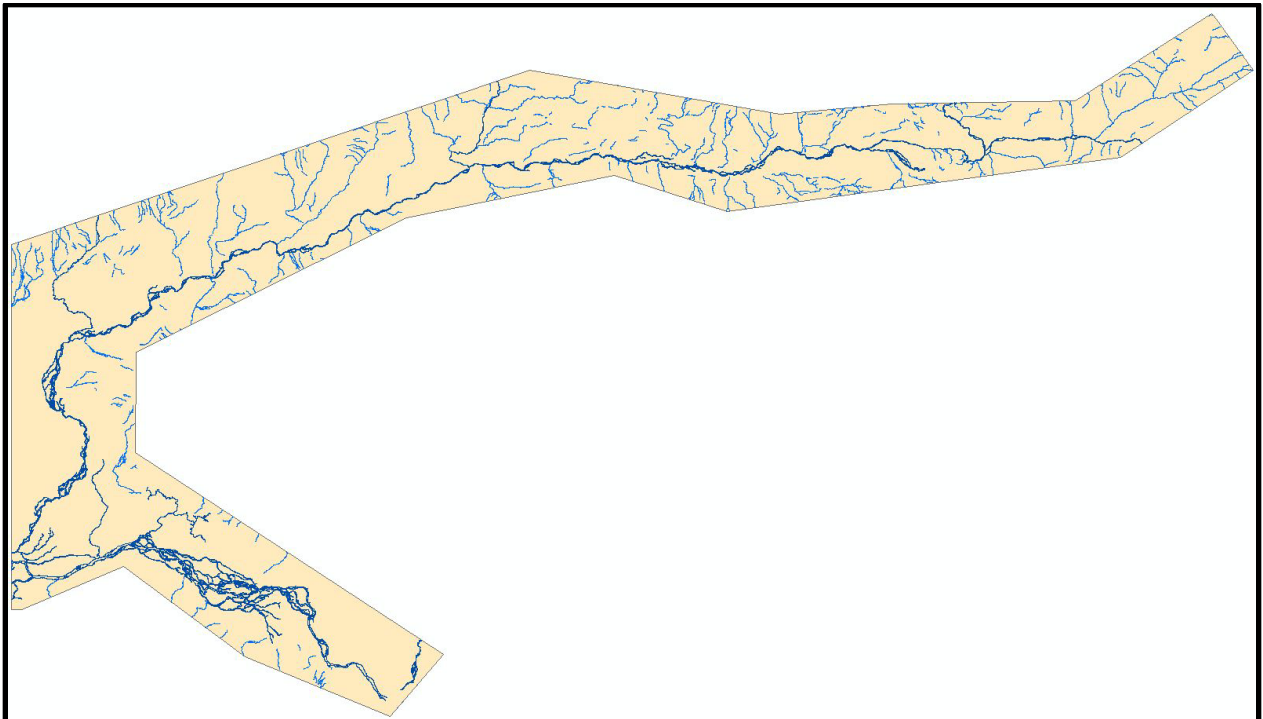
Figure 31, Contractor Supplied Hydro GIS Layers.

The bare-Earth gridded DEM is hydro flattened according to contract specifications. To verify this and to insure consistent heights were retained over water features, GIS analysis was performed on the contractor supplied data. The hydro breaklines include lake polygons, and either single for small streams and double breaklines for larger streams are included (see Figure 31). First the lake polygons were used

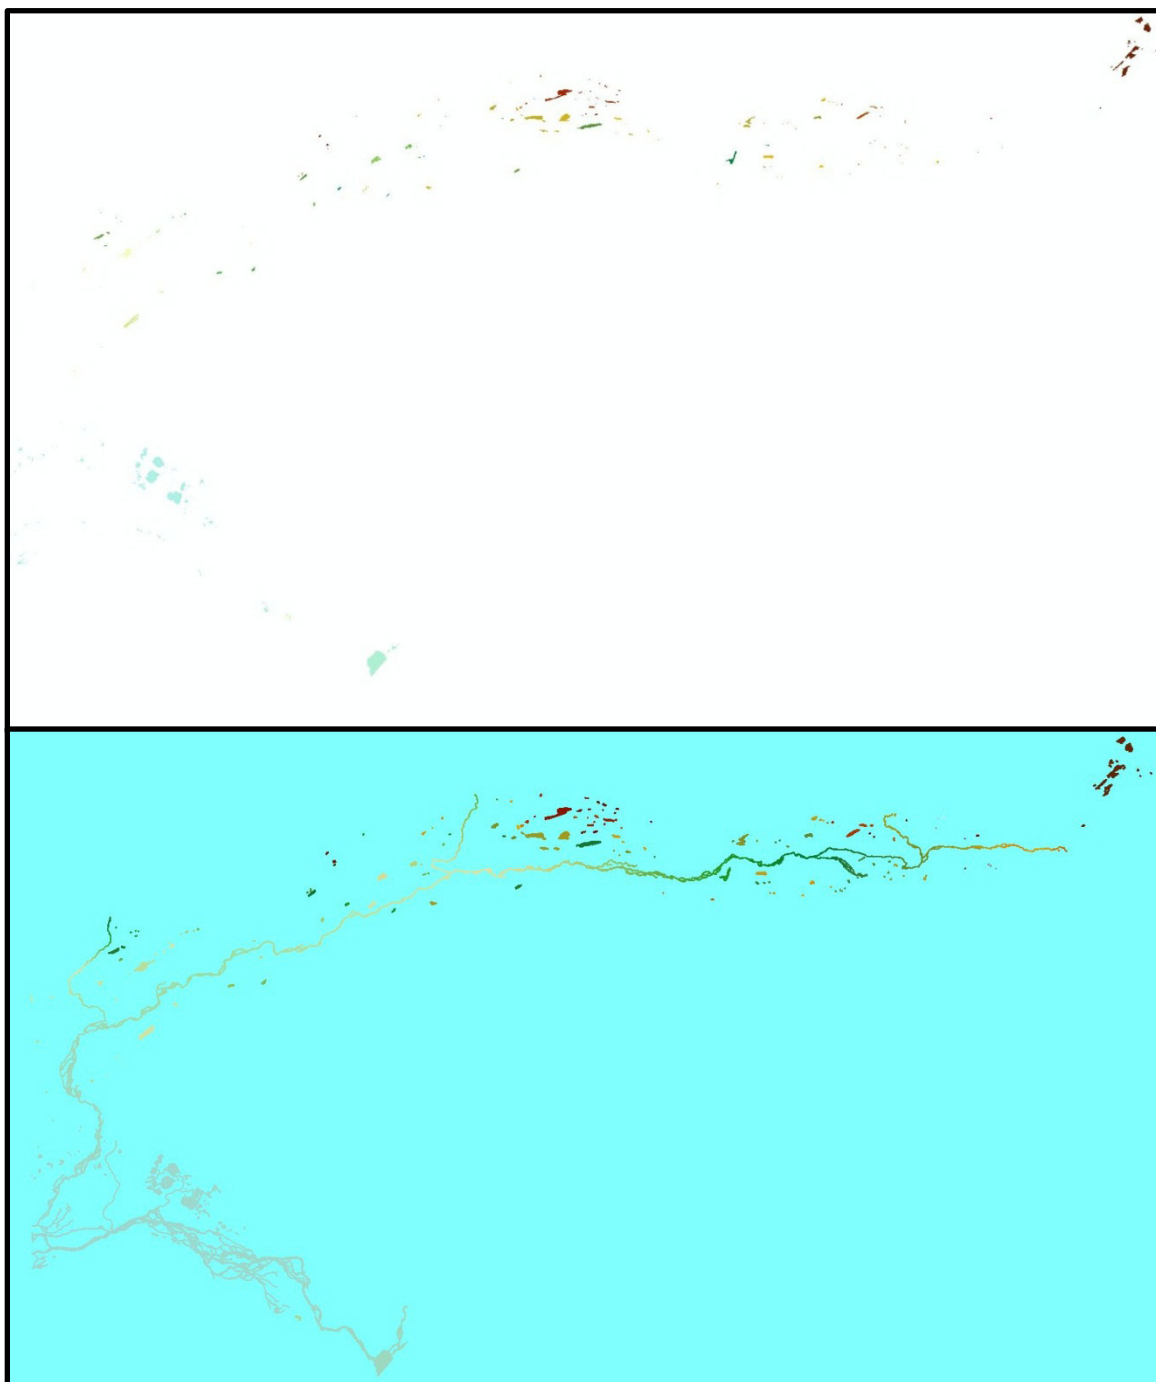
Figure 32, Lake Elevations (top Hydro Flattened DEM, bottom LiDAR Point Cloud).

to clip the bare-Earth DEM elevations for lake heights. This was compared to the water heights layer from the point cloud data. By loading consistent color map, contract stretch method to linear and minimum/maximum height range into both ArcMap and Quick Terrain Modeler the resulting images can be compared for consistency. Streams greater than 100 feet nominal width and a list of nineteen streams supplied by the Matanuska-Susitna Borough should be delineated with double breaklines. These polyline structures are combined to create polygons for each stream or river contained in the block. The hydro breaklines were delivered as polylines, so additional editing was needed to separate major rivers and streams from each other as individual polygons. Then the bare-Earth DEM was clipped for each river, stream, or slough, colorized and compared to the point cloud layer for that specific water body. A similar approach is taken within Quick Terrain Modeler for the specific water body so that the heights of the flattened water can be compared to the original LiDAR returns over that water surface. In this way, all streams could be checked for flow direction, magnitude, and consistency to the original LiDAR returns over that water body. In some cases, stream width and long length of smaller streams required dividing a stream into multiple equal length sections to retain visibility of the resulting image. For the Matanuska block, we analyzed lakes (see Figure 32) and streams including Bodenbug Creek (see Figure 33), Chickaloon River (see Figure 34), Eklutna Powerhouse Creek (see Figure 35), Ezi Slough (see Figure 36), Fortress Creek (see Figure 37), Glacier Fork Knik River (See Figure 38), Jim Creek (See Figure 39), Knik River (See Figure 40), Matanuska River (see Figure 41), and Tsadaka Creek (See Figure 42). All water bodies looked good.

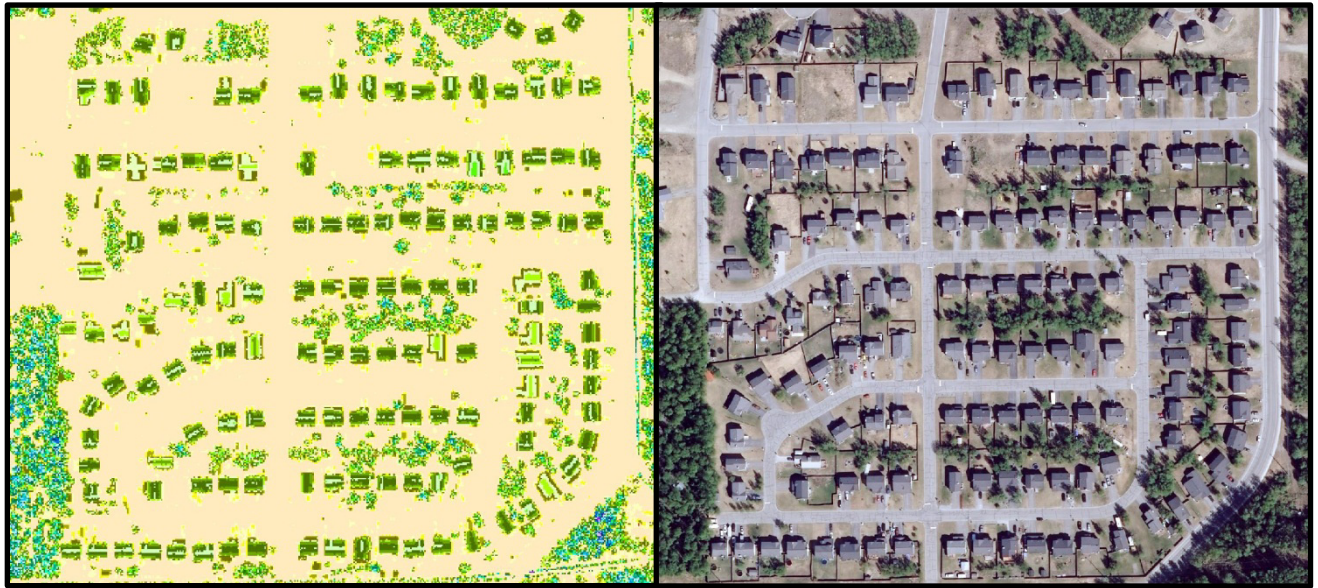
The building feature class is verified by performing a detailed examination of the quarter tile with the most buildings. Visual verification is performed on each building to the ortho imagery or canopy height difference classification (see Figure 43 and 44) looking for buildings that were missed or classified building that were incorrectly identified (false positives). Buildings of greater than 400 square feet should be included at 97% success rate. Separate feature classes are created for new buildings and buildings that were misclassified (false positives). Areas are calculated for new buildings and the accuracy for this quarter tile is checked and reported. Given the limited time, the quarter tile with the highest building density was checked for accuracy and reported as representative of the block. For the Matanuska block, tile MAT_024_SW was identified as the quarter tile with the most buildings in it, including 1197 buildings. I then performed my analysis and found 13 false positives of which 3 were greater than 400 square feet. There were 6 missed buildings of which 1 was greater than 400 square feet. If we only

Figure 43, Building Analysis – Ortho vs. Canopy Height Classification.

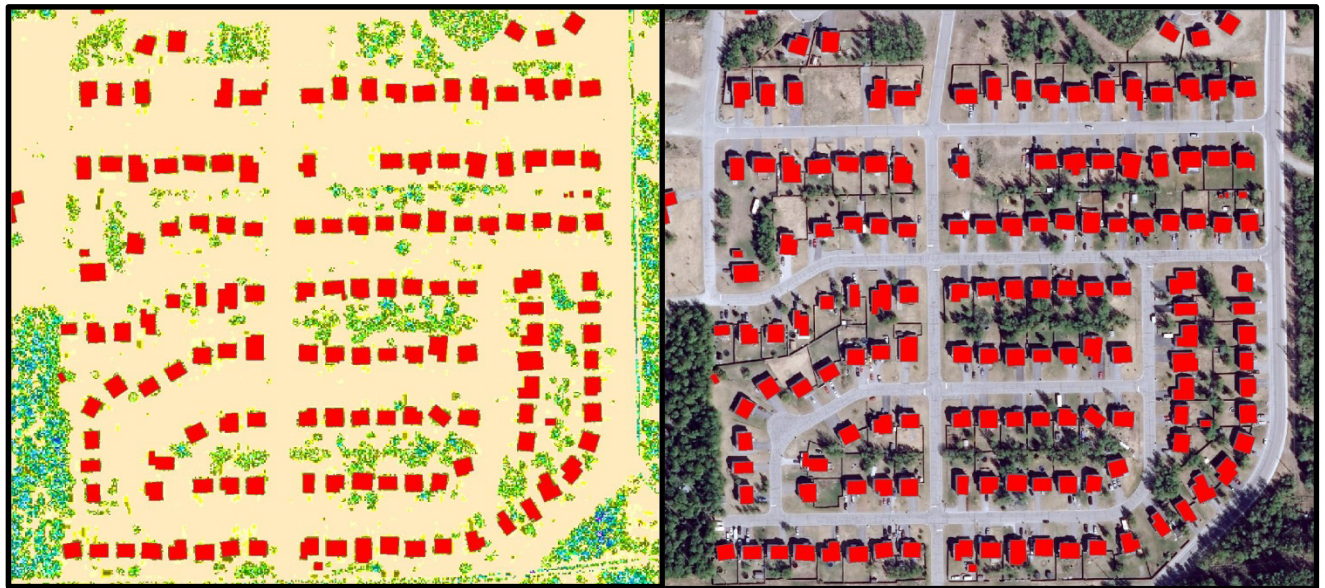
consider buildings with 400 square feet or more, then there were 3 false positives and 1 missed building from 1043 correctly identified buildings. There were 4 errors from 1044 buildings giving a failure rate of 0.36% or an accuracy of 99.64% which exceeds the target accuracy of 97%. A final building analysis graphic (see Figure 45) was produced with accurate buildings (light blue), incorrect buildings (red), and new buildings (dark blue) to document results from the analysis. Separate feature classes for each of the three categories are also produced for further analysis and provided to the Matanuska-Susitna Borough GIS staff.

Figure 44, Building Analysis – Ortho vs. Canopy Height Classification with Building Footprint.

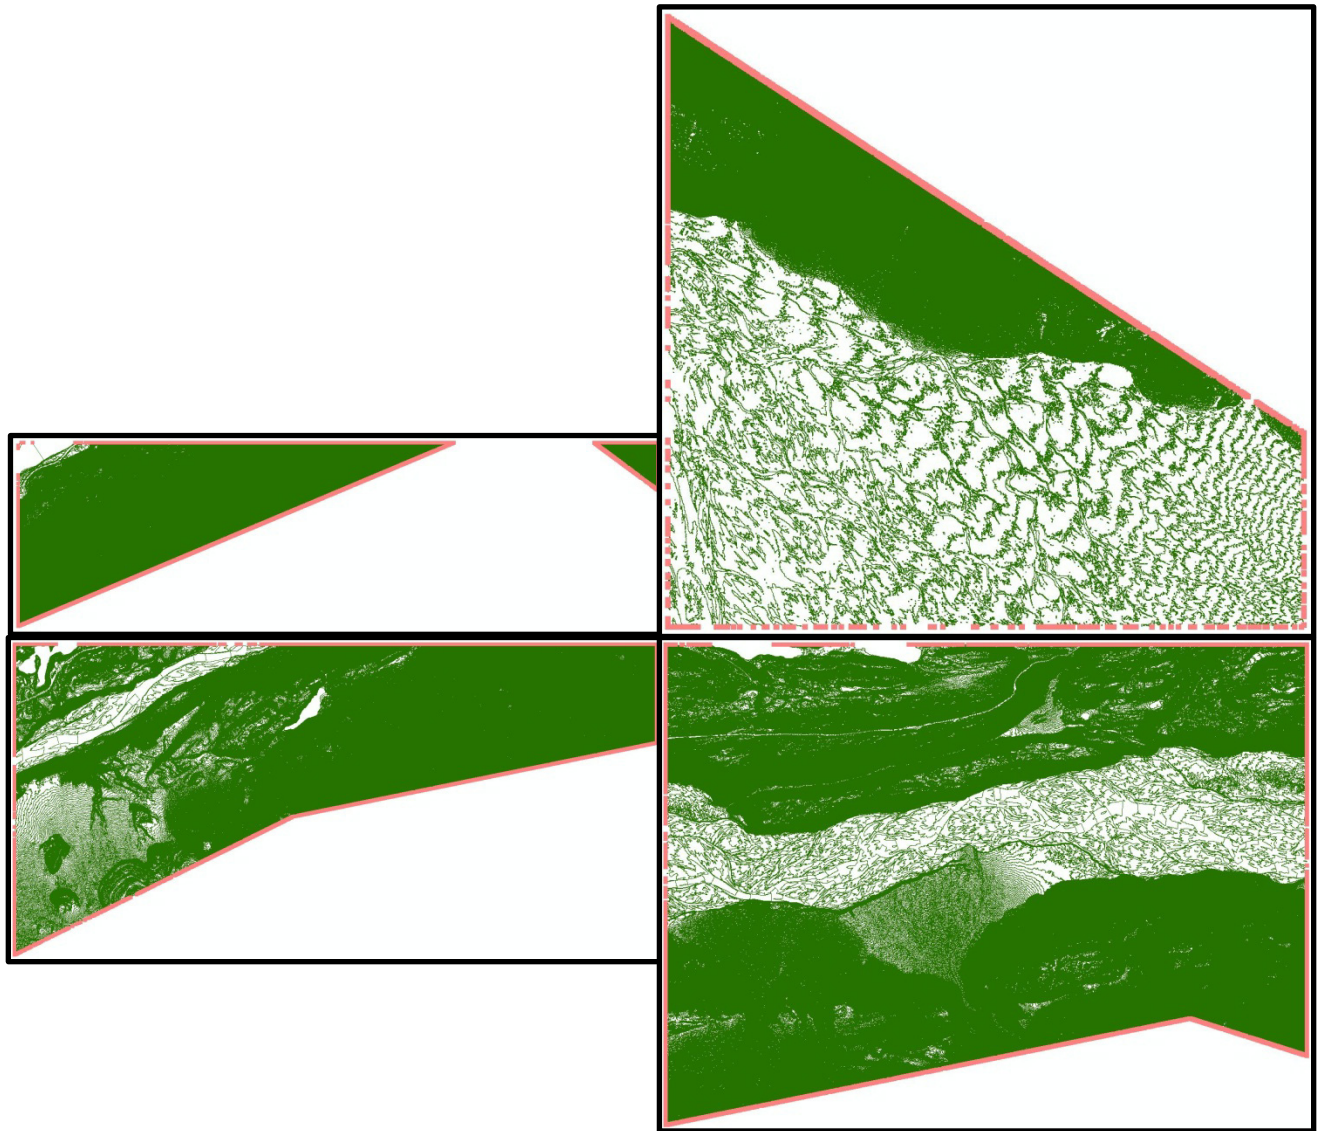
The elevation contours are supplied in two different formats, one as a polyline feature for each tile in the block geodatabase, and the other is in AutoCAD format DXF format. A set of four contour tiles are displayed as an overlay to the bare-Earth DEM and visually examined for consistency. Due to limited time, only a statistical sample of the data is evaluated. The Matanuska-Susitna Borough GIS staff suggested that UAF pick contour tiles with the steepest slope as candidates for testing. A slope map in degrees was first generated from the bare-Earth DEM mosaic and colorized with a blue to red color map with steepest terrain in red (see Figure 46). From this map, tiles with the steepest terrain were selected. Each of four tiles were displayed and compared with the bare-Earth DEM elevations for that tile. The tighter the space between contours, the steeper the slope should be in the corresponding DEM. This can be visually compared to how rapid the change in color is of the underlying DEM. Next, UAF created topologies for each of the selected tiles, testing for contour topology errors based on four selected rules. These rules include: there are no intersects, there are no overlaps, there are no dangles (except at tile edges), and must be single part. Each contour tile was then evaluated to these topology rules and errors were documented and reported to Aerometric. For Matanuska block, four tiles tested initially showed topology errors that needed to be fixed. After subsequent analysis and testing, the problem was tracked to a service pack upgrade of ESRI software on the UAF computer. After upgrading the software, we doubled the number of tiles tested to verify that everything was good (see Figure 47 and 48).

Figure 47, First Four Topology Checks.

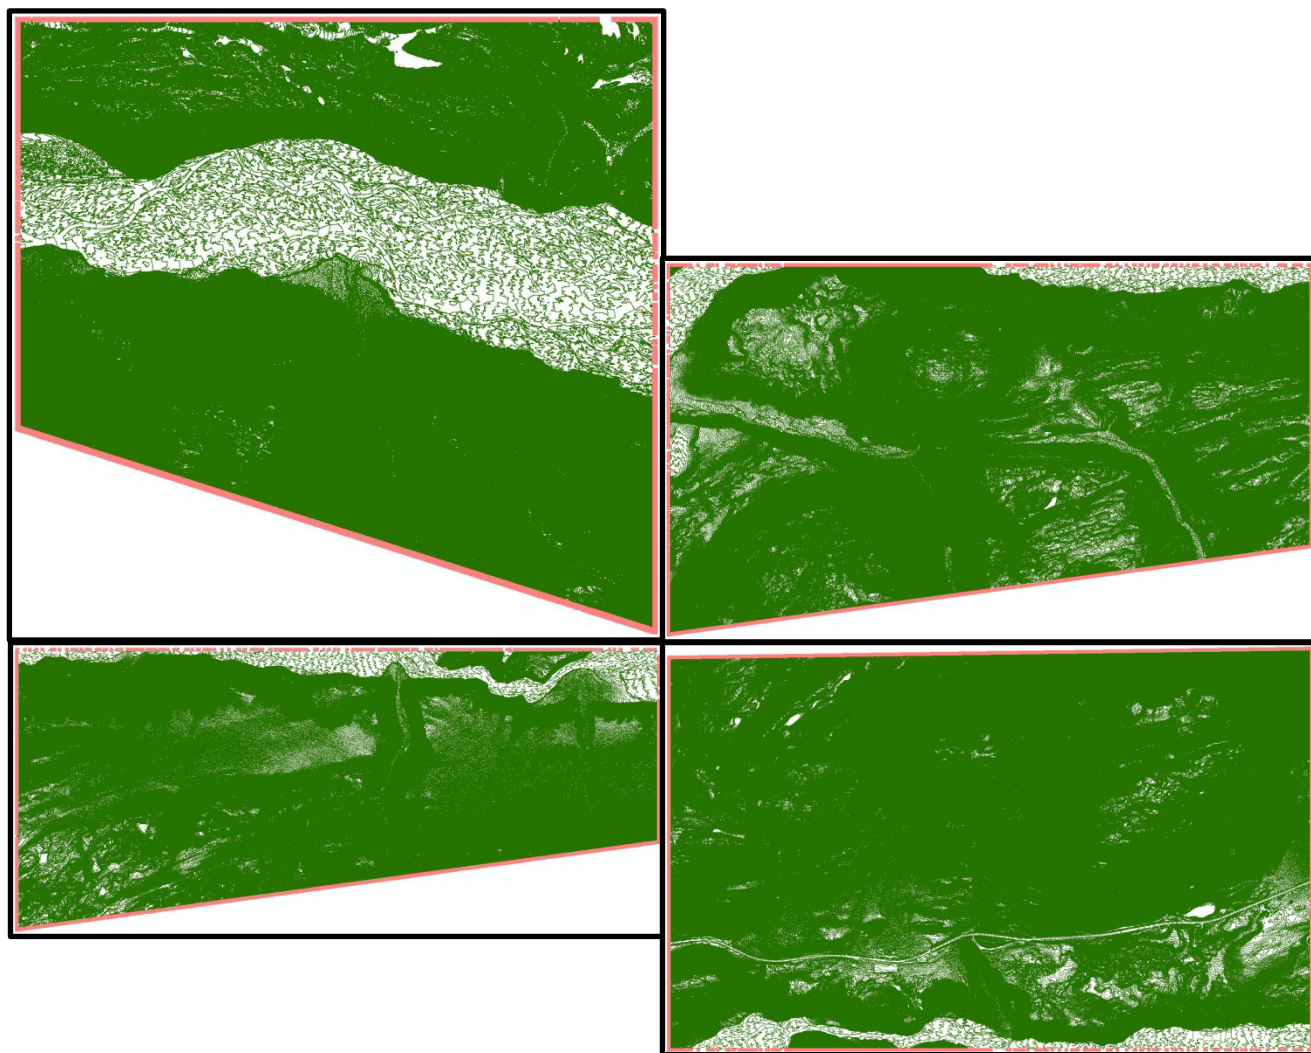
Figure 48, Second Set of Four Topology Checks.

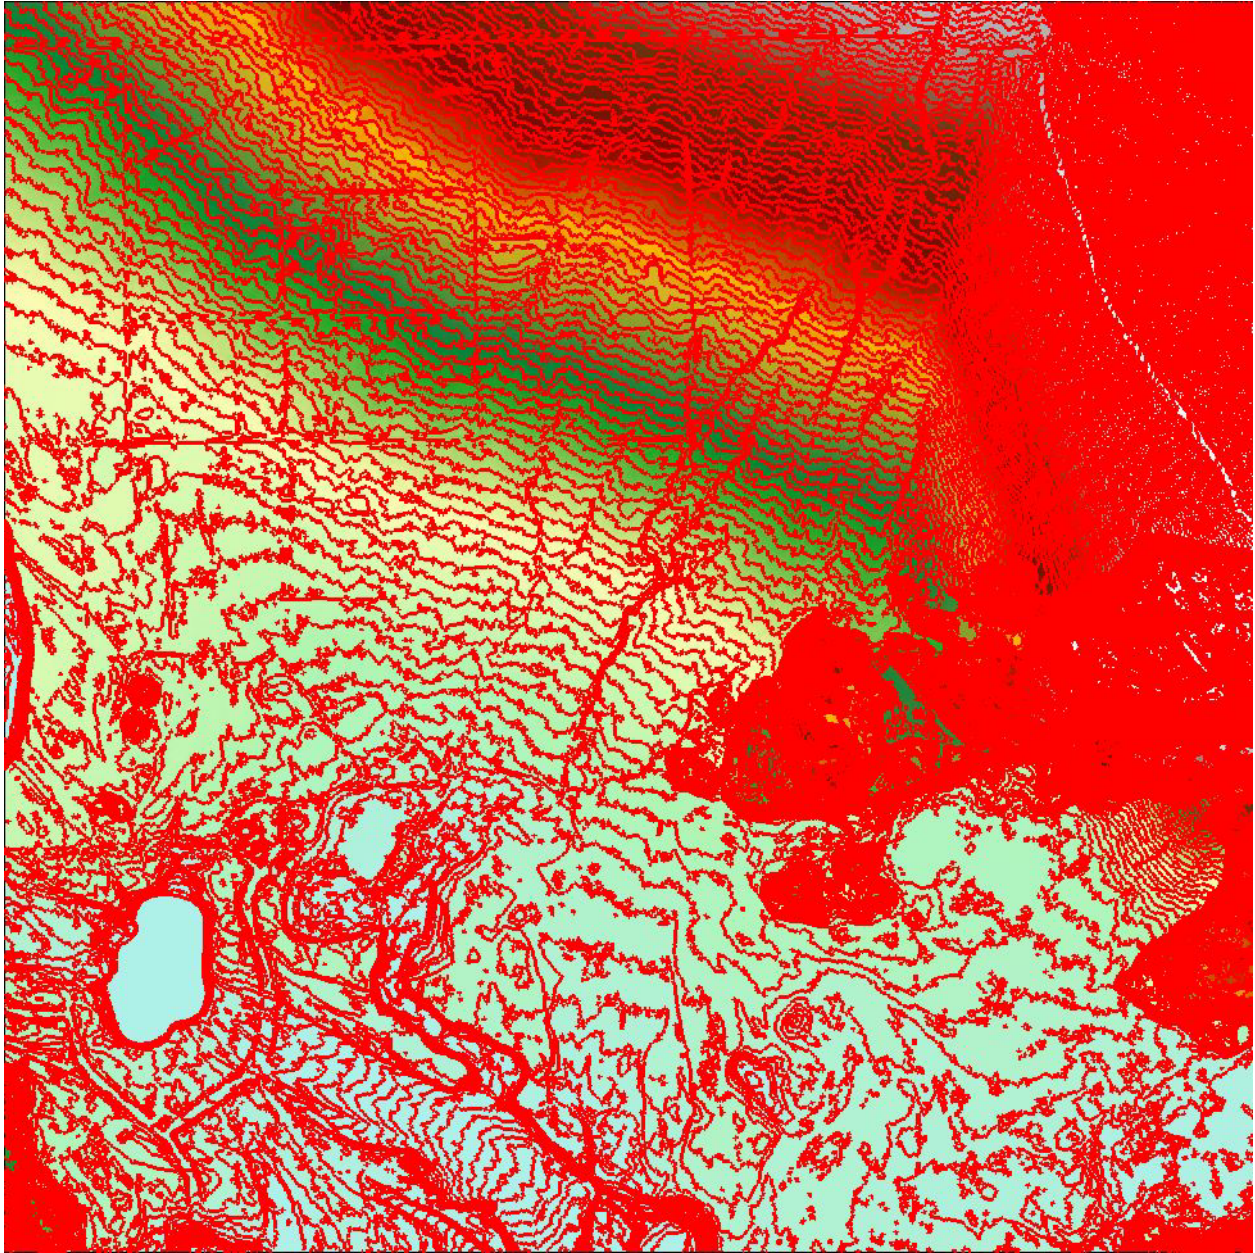
Quick Terrain Modeler has an ability to drape the AutoCAD contour files in DXF format over a corresponding DEM and visualize it in either 2D or 3D. This capability was used to spot check the DXF files for problems (see Figure 49 and Figure 50). The selected Matanuska contour products were spot checked for completeness and accuracy.

Figure 49, DXF Contour 2D Drape in QTM.

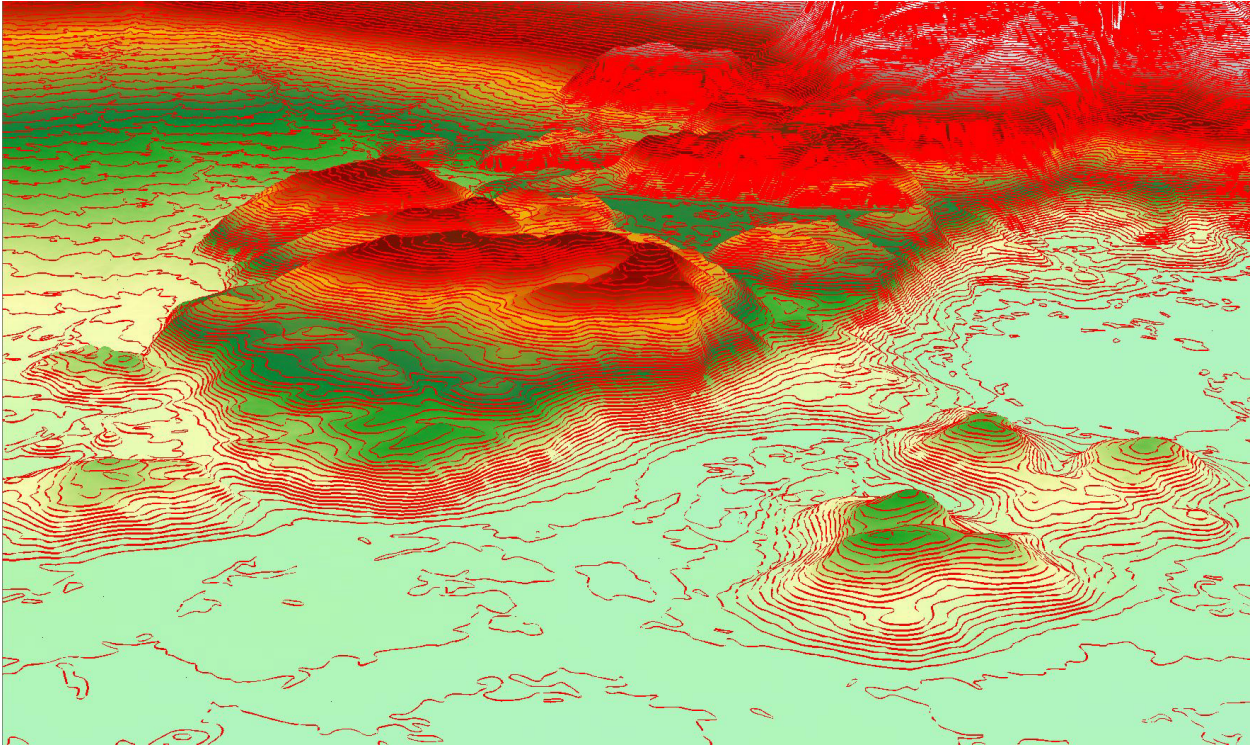
Figure 50, DXF Contour 3D Drape in QTM.
